Five-Year Review Report
Second Five-Year Review Report
for

Hedblum Industries Site

Au Sable Township

September 2004

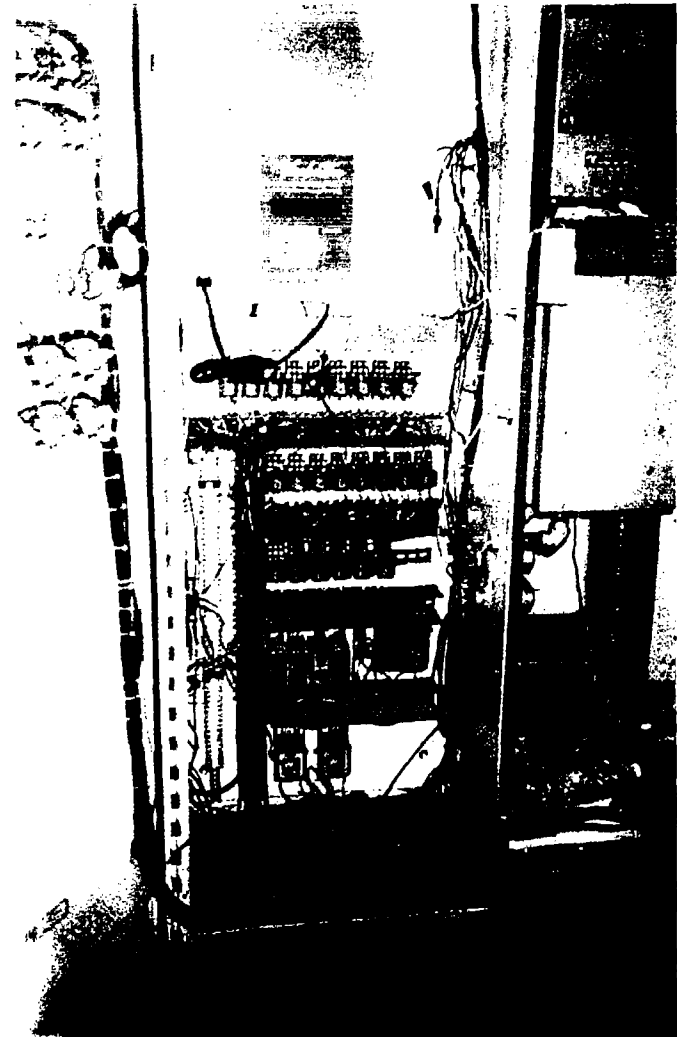
Figure 8. Inside view of the electrical panel.

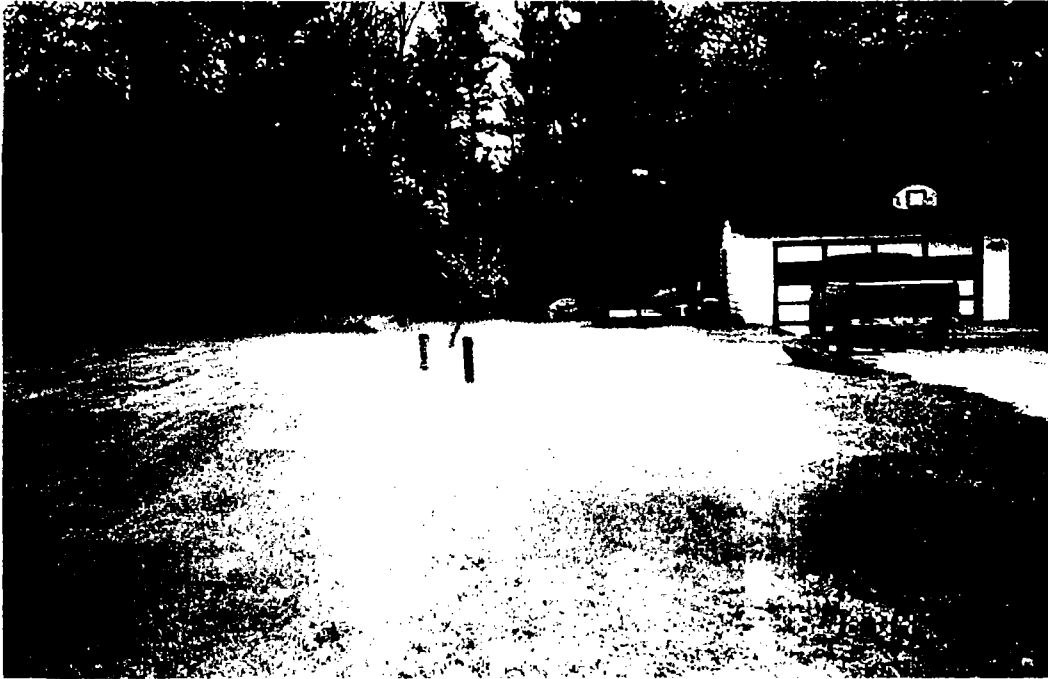
Figure 11. Looking East: Monitoring wells (MW) 5S and 5D, about 100 feet east of Franklin Street

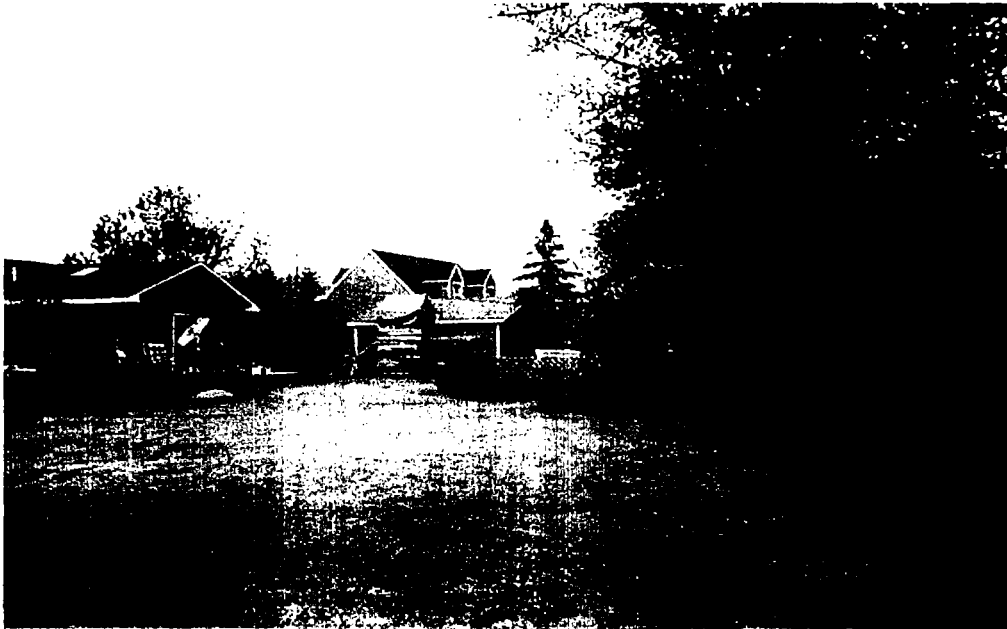
Figure 13. Looking Northeast: Monitoring well MW-14 just outside dog pen, and MW-15 inside pen and just north of MW-14. The cross-hatched fence in deep mid-ground is the dog pen.

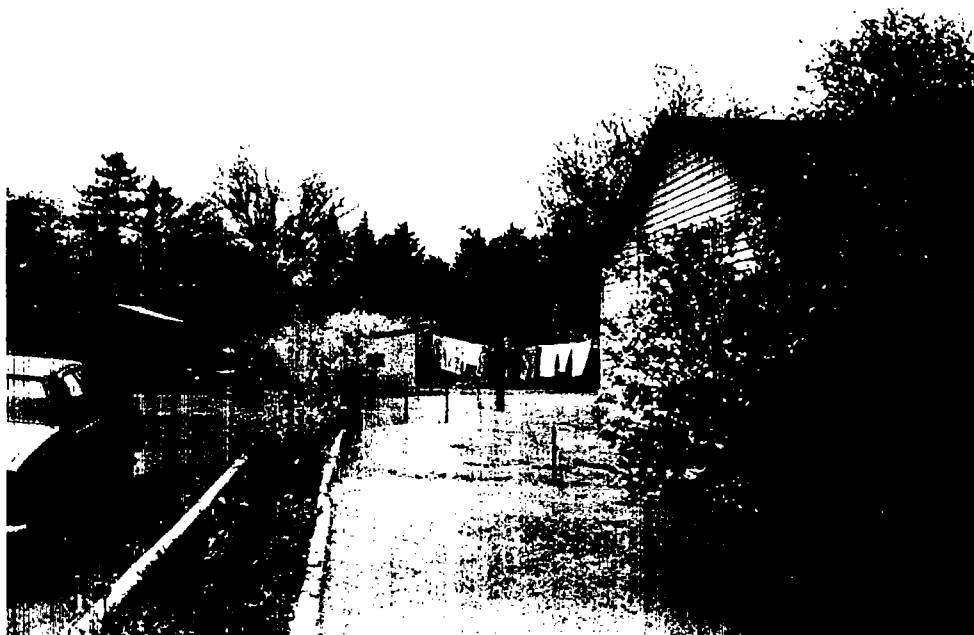
Figure 18. Looking West: Monitoring well MW-10 (left) and MW-11 (right) are located immediately behind the mid-ground fenced area.

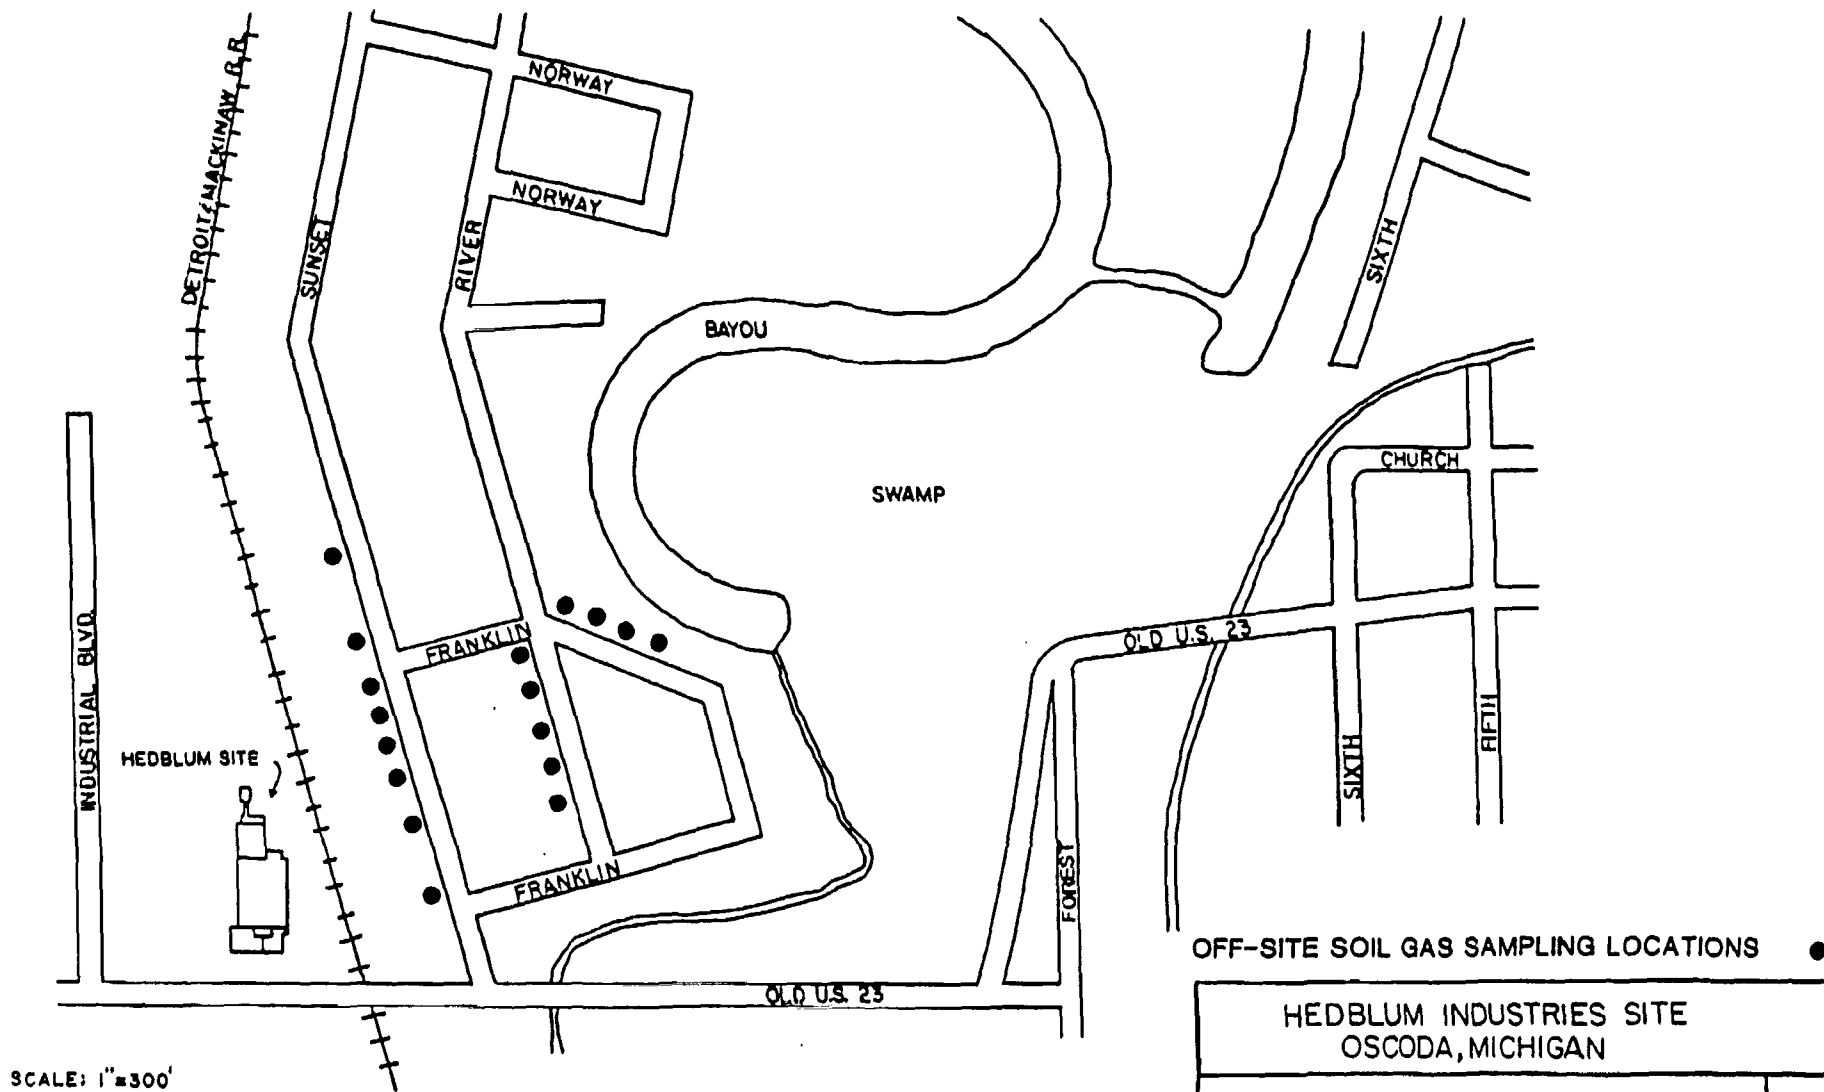
5

The soil gas investigations resulted in the delineation of a TCE plume as shown in Figure 5. The source area of highest concentration (68.67 ppm) was found below a former loading dock. High soil-gas concentrations were also evident around the former buried tank location (1-10 ppm). The plume appears to be migrating in an easterly direction (the probable direction of groundwater flow). Data results can be found in Appendix B.
